PROPERTY INSPECTION REPORT

Concerning: **1001 Anywhere Ln. The Woodlands, Tx 77380**

By: **Rodney Sims / Lic# 10271**

12/30/2009 / 10:00 AM

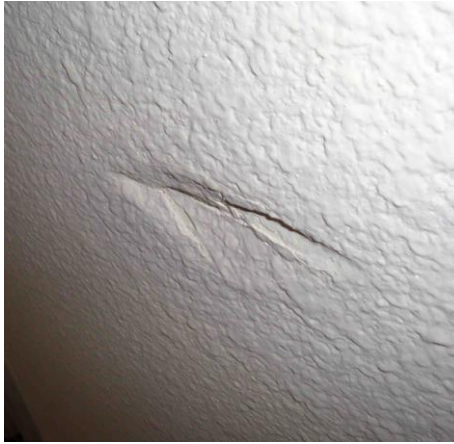
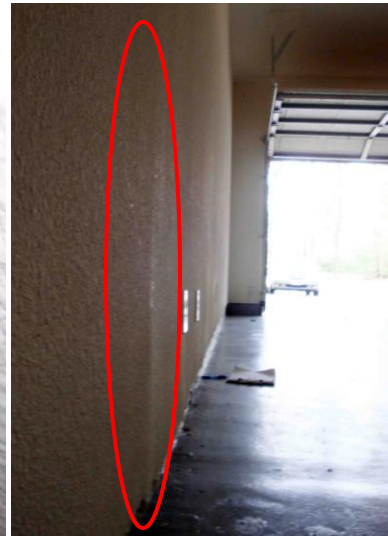
-There was a damaged area of drywall in the back of the garage at the lower left of the window.

-On the lower right garage wall, there is an irregular area of drywall which protrudes outward and is not securely nailed to the studs.

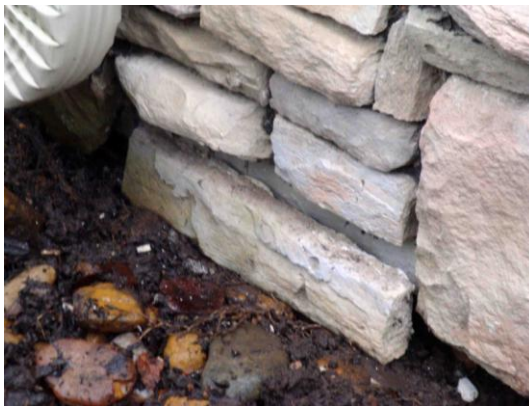
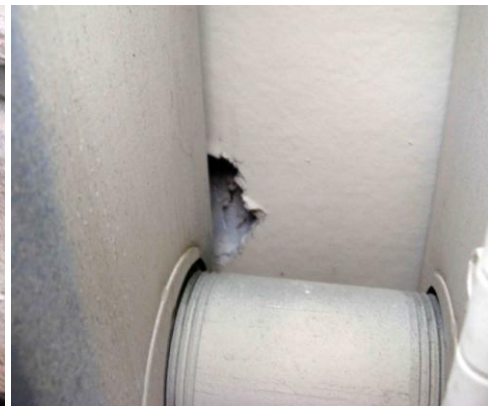
-On the front right pillar, the lowest stone on the outer side is detached.

-On the right side of the electric sub-panel, there is a hole in the siding that should be filled.

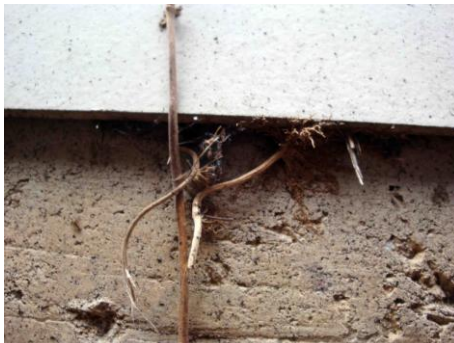
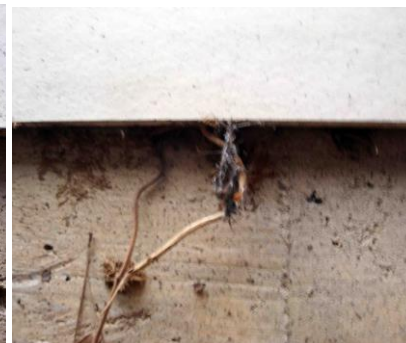
-On the left side, there is dead vegetation that had grown behind the siding.

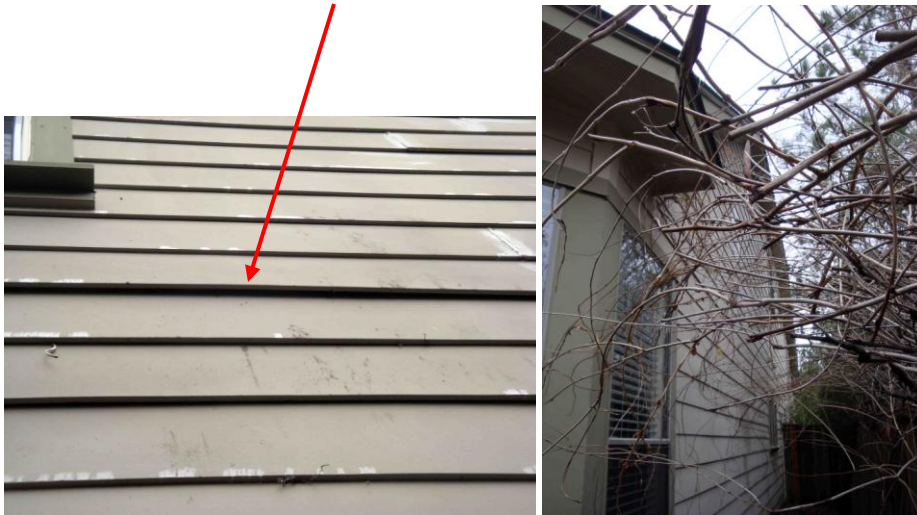
-On the upper left side, there is one piece of hardy board that is not secured properly.

-On the left side, there are tree branches in direct contact with the house.

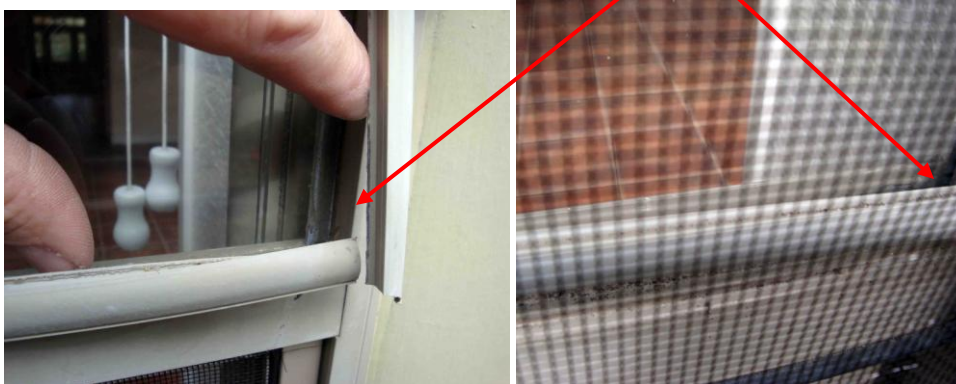
-There were damaged window pane 'glazing beads' in several windows (such as in the back den windows, and master bedroom).

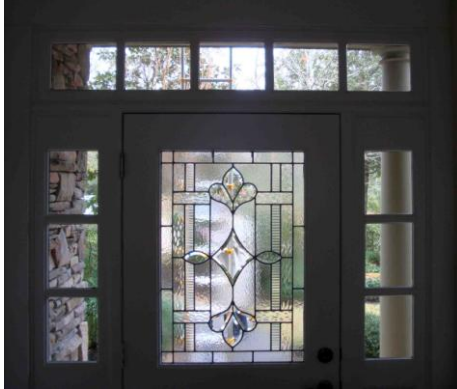
-Safety Glass was not present as required on the windows on each side of the front door.

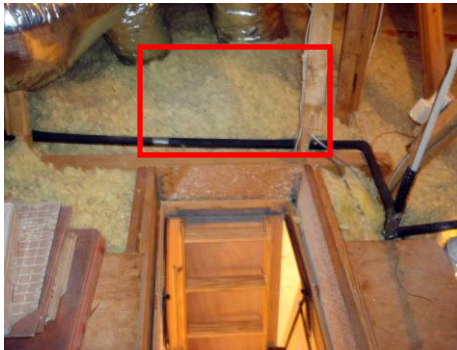
-The fold-down attic staircase does not have the required 'landing area' in the attic.

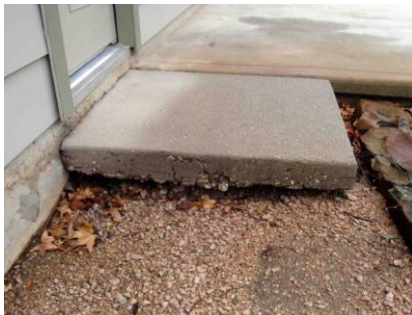
-The small porch behind the rear garage door, has areas where the soil has eroded underneath. (This should be filled in underneath and to the sides to stabilize it)

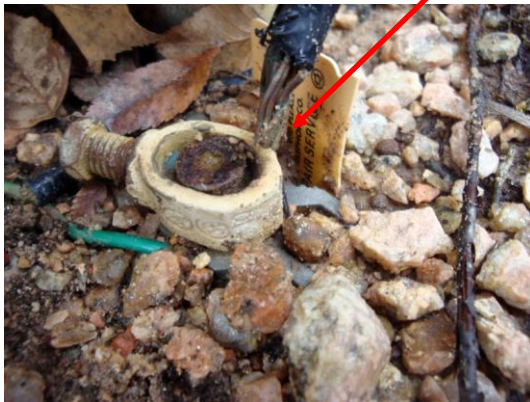
- The aluminum main feeds are not coated with anti-oxidant paste.
- The white wires used as hot wires are not marked as such.
- Some of the breakers are not labeled as required, or not properly labeled.
- None of the required locations in the house were protected by Arc Fault Breakers as is required by current building code. Even though this may have not been required at the time of construction, TREC requires that licensed inspectors flag this condition with a "D" for "Deficiency". For more information, refer to the TREC OP-I Form at the end of this report.
- The grounding wire is completely disconnected from the grounding electrode.

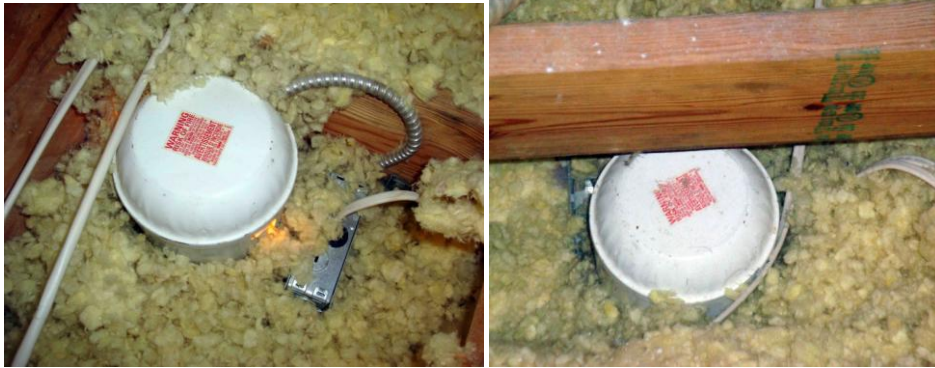
- None of the receptacles in the garage were GFCI protected as required.
- Light fixtures in the garage do not have the covers or globes as required.
- The bedroom-1 shower light is not functional.
- The bedroom-1 receptacle is controlled by the GFCI receptacle in the guest bathroom. HOWEVER, the guest bath GFCI receptacle will not 'always' reset the bathroom receptacle properly after being tripped.
- The receptacle is not secure on the left side of the entrance hallway.
- The receptacle is not secure on the back wall of the study.
- In the finished room off the garage, the left wall does not have a receptacle as required.
- Several recessed light cans in the attic were NOT RATED for direct contact with

combustible materials, BUT WERE in contact with combustible insulation. (This is a fire safety requirement) (There was direct contact with the insulation)

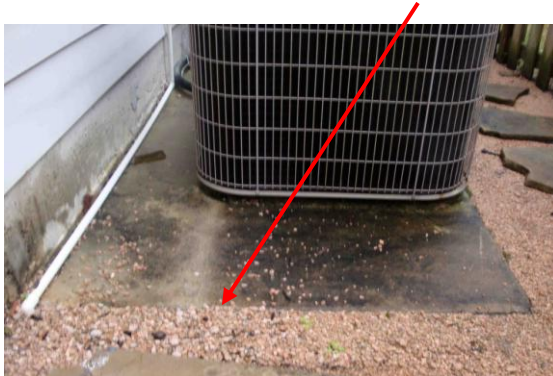
-The top of the condenser pad does not have the required vertical clearance above grade.

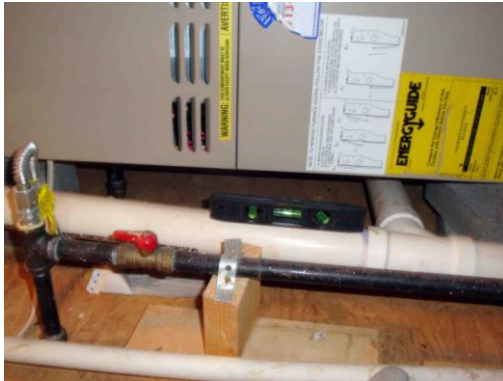
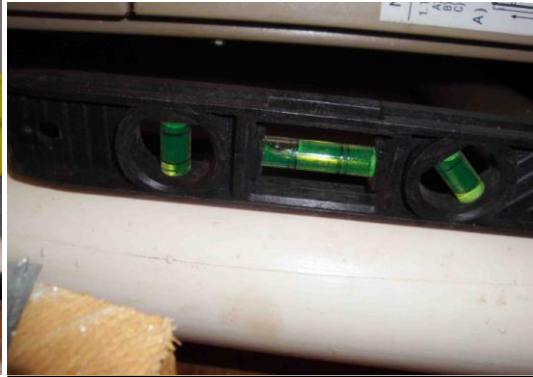
-In the attic, several of the vents are tied together. HOWEVER, some sections of horizontal connecting pipe incorrectly slope toward the vent at a downward angle, which could cause accumulation of rainwater in the vent system.

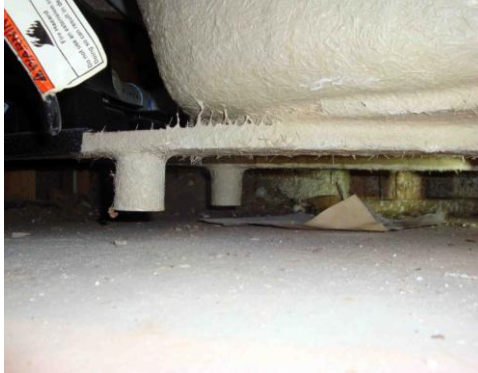
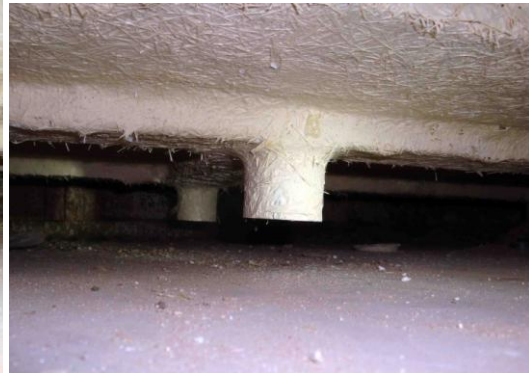
-The Hydro-Massage Therapy tub is not properly mounted and supported at the base.

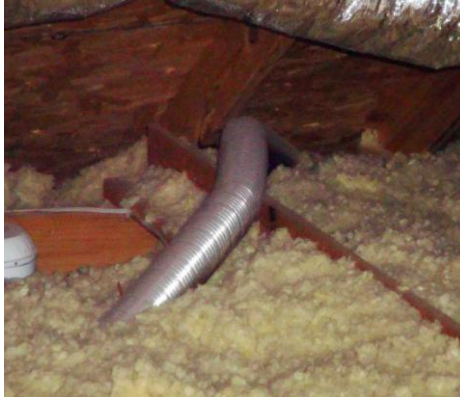
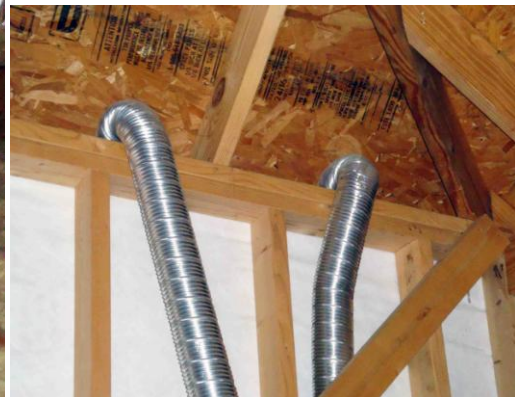
-The mechanical exhaust vent(s) do not exit to the outside air as required.
 (Exiting into a 'soffit' is 'not' allowed)

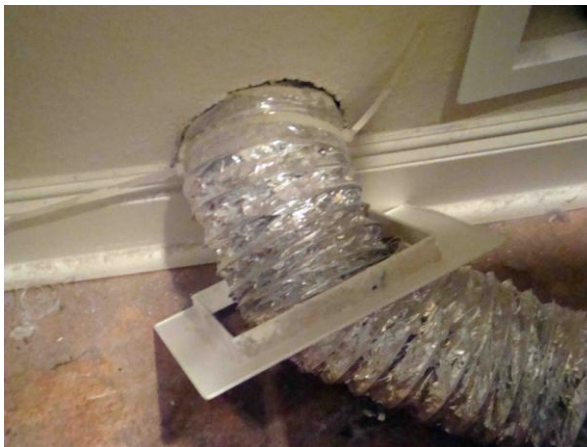
-The dryer vent face plate is completely loose and has no box to mount onto.
