# PROPERTY INSPECTION REPORT

Concerning: **1234 Anywhere Lane The Woodlands, Texas 77380**

By: **Rodney Sims / Lic# 10271**

**02/13/2010 / 9:00am**

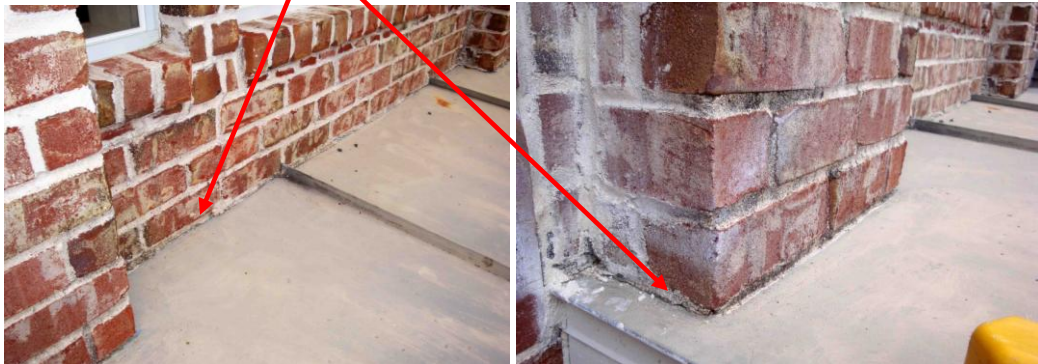
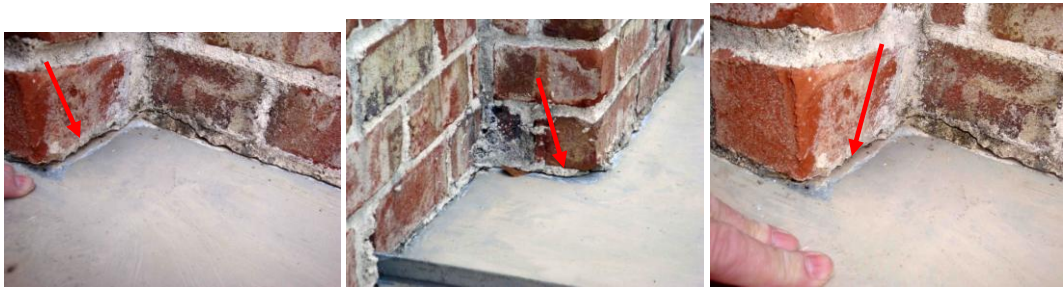
**-At the flat metal roof above the front porch, the inspector noted that the brick installation 'may' not conform to standard installation methods.** (The bricked area in question 'appeared' to rest directly on the porch flat metal roof material. Typically, brick in an area such as this, rests on a metal 'intel' of other appropriate supporting structure) (See the photos provided.)

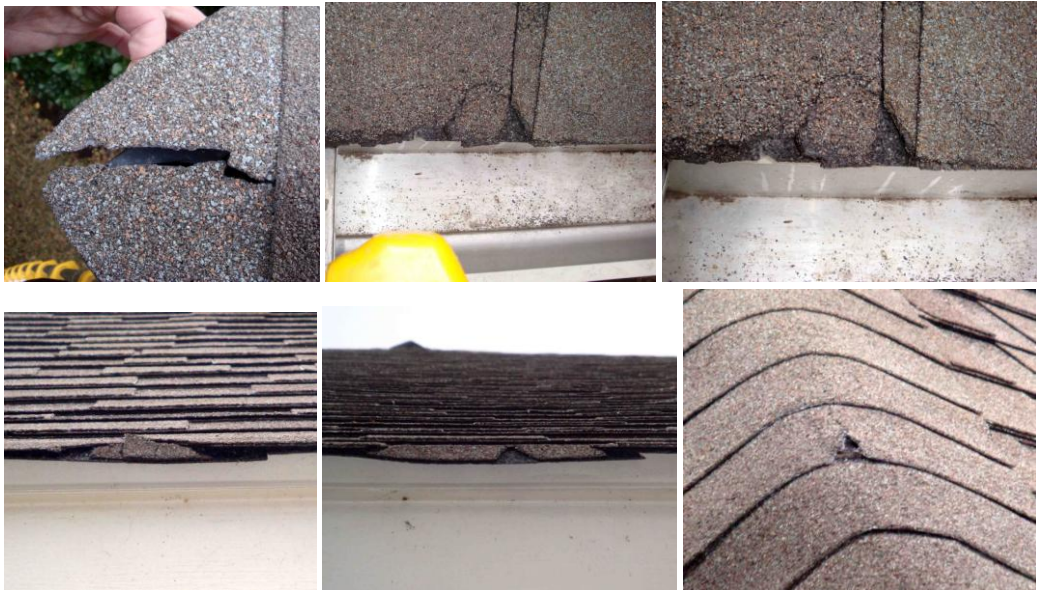
**-Minor shingle damage was noted on the lower edges in several locations.** (mostly located along the front, front right corner, and front right ridge)

**NOTE: Due to issues noted, the inspector recommends examination of the Roof Covering Materials by a 'competent' roofing specialist company.**

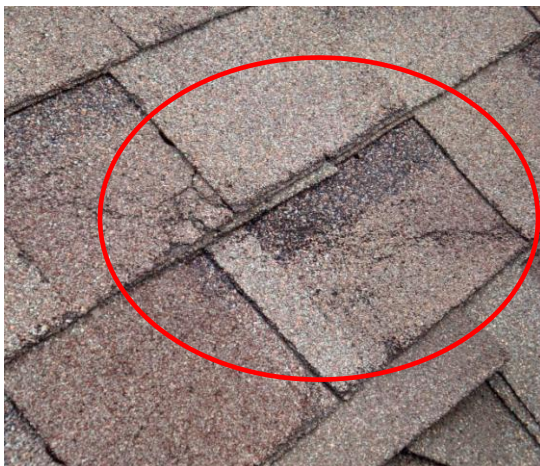
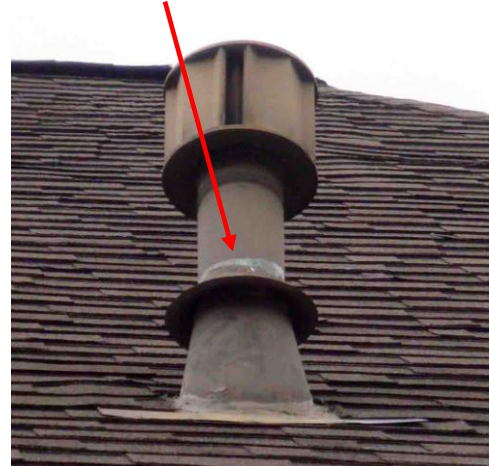
**-In the back, just above the chimney, either 'age' or 'damage' to the shingles was noted.**

**-On the back side, one exhaust vent 'appears' that the rain collar may not be attached well.**

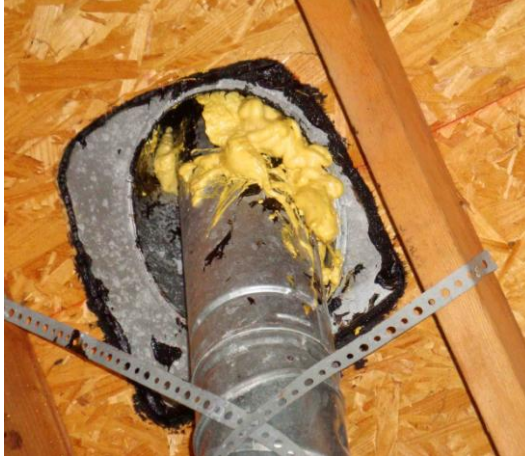
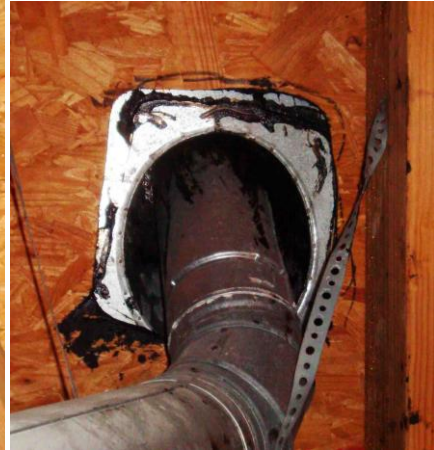
-One of the exhaust vent flashing, (possibly the one in the above right photo), is incorrectly sealed with both spray foam and tar on the underside.

-A second exhaust vent flashing is also incorrectly sealed with tar on the underside.

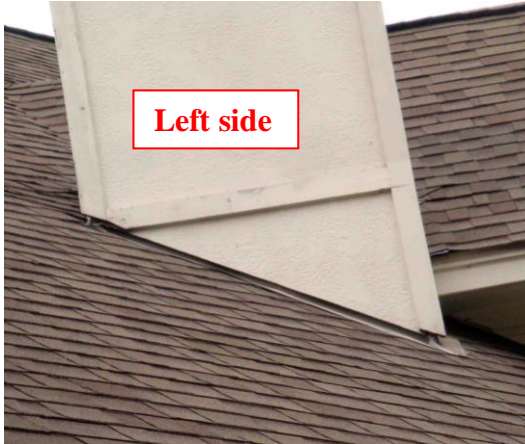
Left side

-The inspector noted 'several' areas of questionable roof flashings around the chimney. (these areas are documented in the photos below)

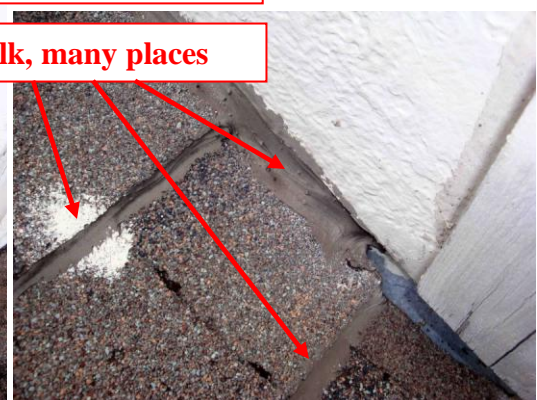
Patched with caulk, many places

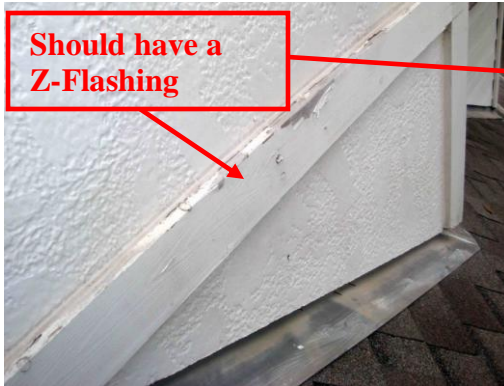
Left side

Siding apparently cut out and flashing should not be 'on the top'

Should have a Z-Flashing

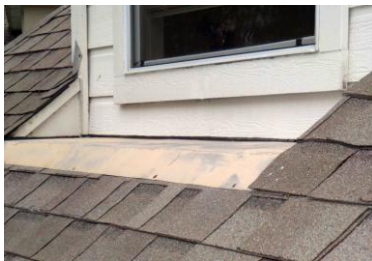
NOTE: On the two flat dormer flashings in the back, due to inaccessibility, the inspector was unable to check that the flat area has sufficient slope to facilitate water runoff. The inspector recommends that 'if' a roofing company is consulted, that this area be checked.

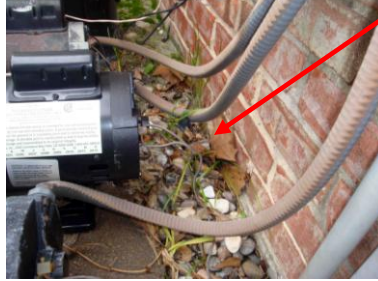
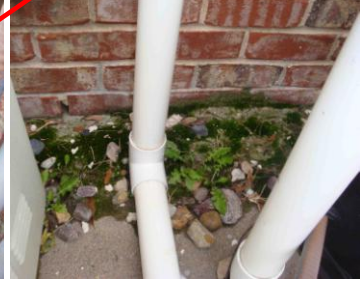
**EXTERIOR:****-There is a 'small' crack in the mortar above the front upper left window****-On the left side, at the pool equipment, the brick does not have the required vertical clearance to the grade. (Algae growth was also noted in this area)**

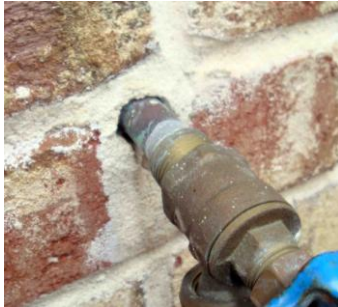
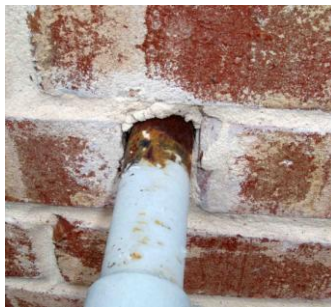
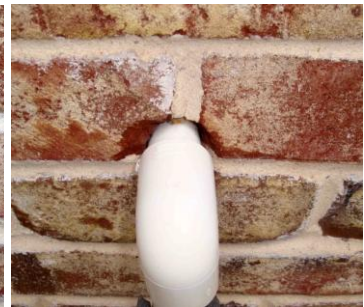
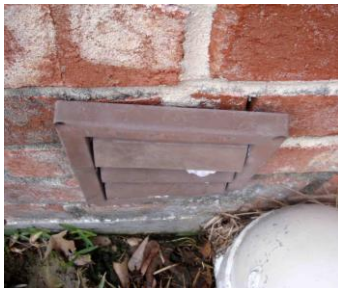
**-All outdoor faucets, gas, other pipes and vents should be sealed with sealant to prevent water penetration through the exterior walls. (see the following photos for examples)**

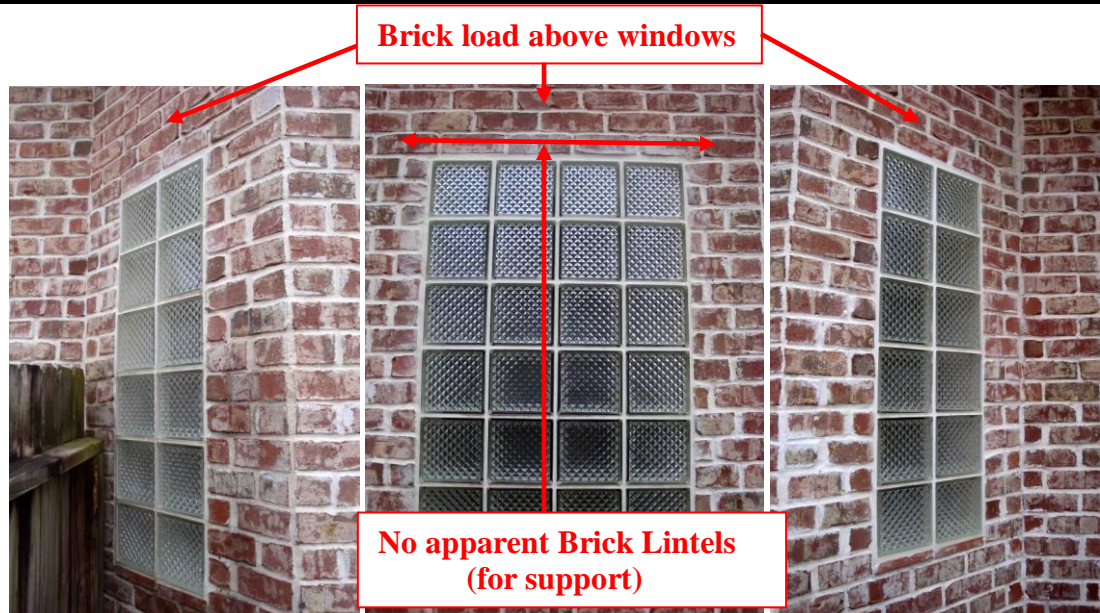
**-On the right exterior wall, a code violation was noted with regard to the 'glass blocks' in the three bathroom windows.** These glass blocks are technically named (Glass Masonry Units). 'Glass Masonry Units' may be used in exterior walls and be connected with mortar. **HOWEVER, Glass Masonry Units are only permitted for use in non load-bearing conditions.** (By definition these units are non load-bearing. Therefore, when they are used in a wall opening, a properly designed header or lintel must be provided. Panels of glass unit masonry must be isolated from the structure so that in-plane loads are not transferred to the glass.)

**The inspector's examination of the three window areas indicated that there is 'apparently' NO metal LINTEL above the Glass Masonry Units to support the load of the brick above the windows.**

NOTE: The inspector did not observe any current adverse effects from the installation, but is obligated to report that the installation method used is not appropriate.

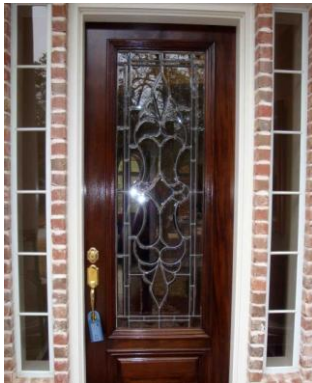
**-Safety Glass was not present as required in the front door.**

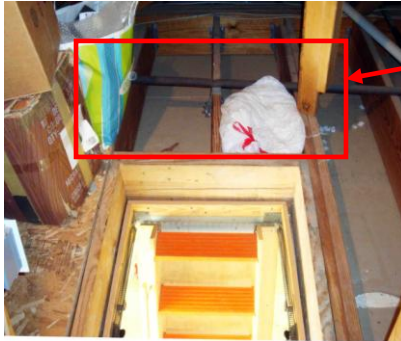
**-The pull down staircase in the garage is not adequately secured to the ceiling joists.** (Code required for it to be secured with 16-D size nails)

**-The attic fold-down staircase does not have the required decked 'landing area' in the attic.**

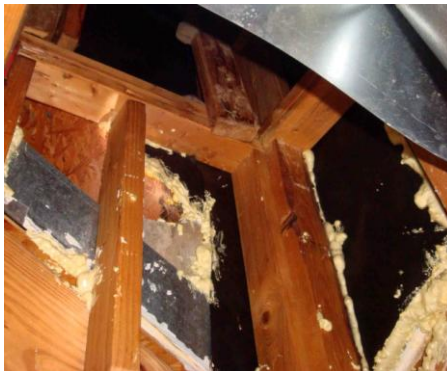
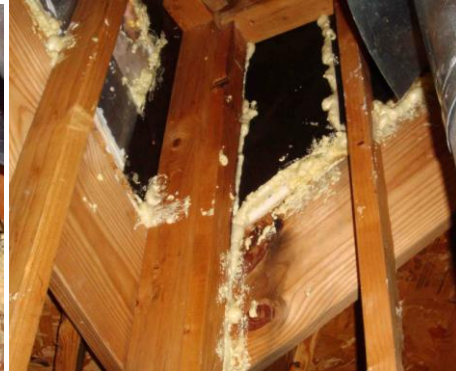
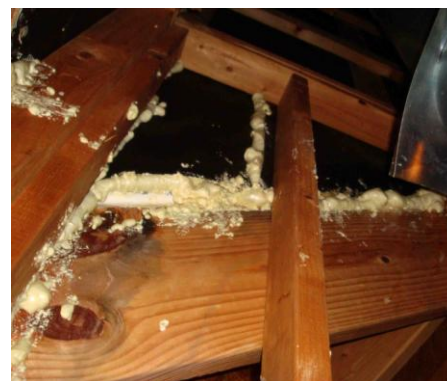
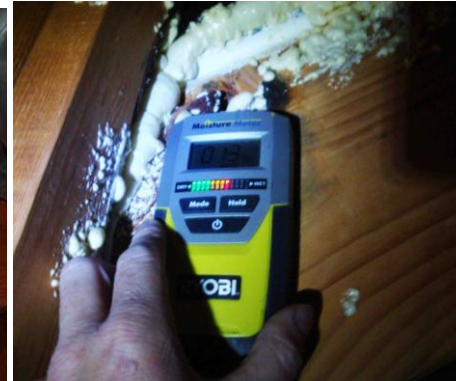
**-The exhaust vent 'damper clamp' is missing.** (This is a required safety device on gas fireplaces.)

**-The wooden chimney area, where it penetrates the roof decking, is incorrectly 'patched' with spray foam.** (Moisture meter testing in the area indicated that some framing members had a 'currently' elevated moisture content.)

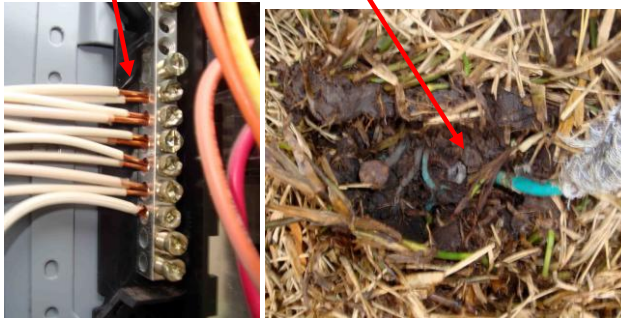
**MAIN PANEL (Outside):****-Some of the breakers are not labeled as required.****-None of the required locations in the house were protected by Arc Fault Breakers as is required by current building code. Even though this may have not been required at the time of construction, TREC requires that licensed inspectors flag this condition with a "D" for "Deficiency". For more information, refer to the TREC OP-I Form at the end of this report.****-'Double lugging' of Neutral wires was noted on the neutral bar.****-The grounding wire is not securely connected to the grounding electrode.**

**NOTE: Due to issues noted, the inspector recommends service and system check by competent licensed electrician.**

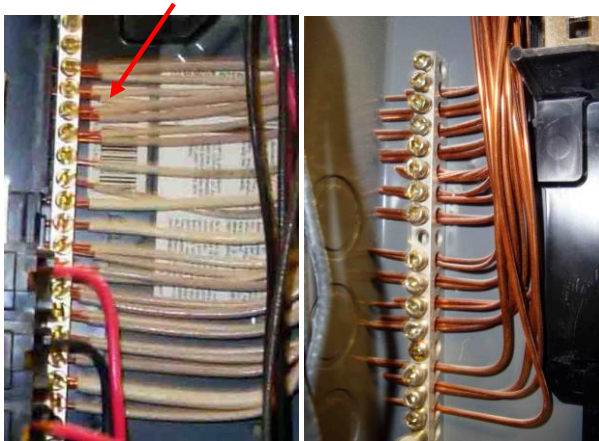
**SUB PANEL (Inside):****-None of the required locations in the house were protected by Arc Fault Breakers as is required by current building code. Even though this may have not been required at the time of construction, TREC requires that licensed inspectors flag this condition with a "D" for "Deficiency". For more information, refer to the TREC OP-I Form at the end of this report.****-'Double lugging' of Neutral wires was noted on the neutral bar.****-Inside the panel box, the inspector was unable to 'definitively determine' a wire on the ground bus bar, which is being used as the 'ground wire' to the outside grounding electrode. (Also, on the outside of the house, the inspector was unable to locate a 'grounding electrode' (with corresponding 'grounding wire') which is connected to the sub-panel.)**

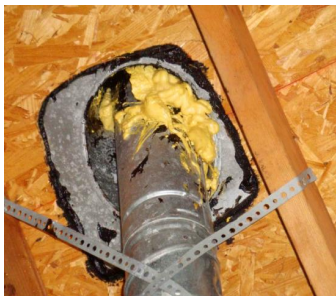
- The exhaust vent, at the roof penetration, is incorrectly sealed with spray foam.
- The spray foam attached to the furnace exhaust vent, causes a code violation because it is a 'combustible material' in direct contact with the vent.

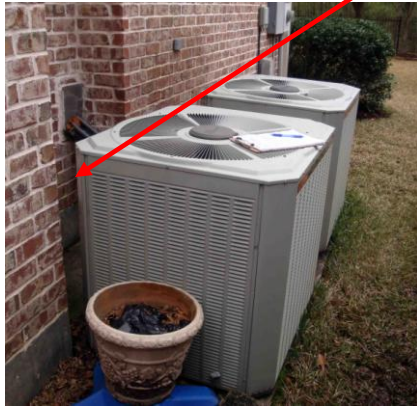
**NOTE: Unit-1 is a Trane XE1200 (High Efficiency) 5-Ton system.****NOTE: \*\*\* The Air Conditioning unit(s) were inspected but were not operated since the ambient temperature was below 60 degrees.****-The unit does not have the required 12" clearance from the house.****-The units do not have the required 24" separation between each other.**

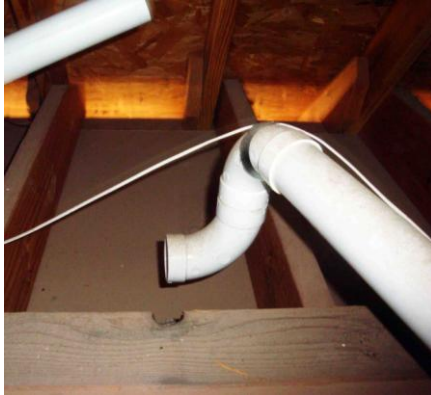
**-In the garage attic, there is a plumbing 'vent pipe' which VERY INCORRECTLY travels horizontally and terminates directly above the ceiling drywall. (This pipe 'appears' to serve absolutely 'no purpose' and poses the risk of introducing rain water, through the vent pipes, and into the attic) (The inspector HIGHLY RECOMMENDS that this situation be corrected)**

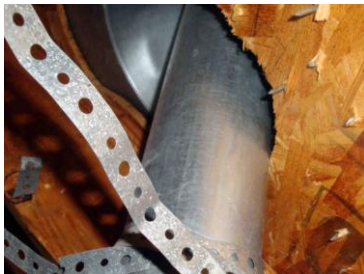
**-The gas vent flue did not have the required 1 inch clearance from wood material where it penetrates the roof decking. (direct contact was noted)**

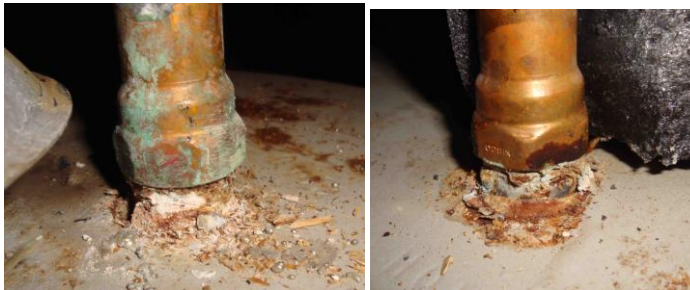
**-The water heater supply lines do not have the required dielectric fittings. (These fittings prevent corrosion)**

**-The water heater supply lines were corroded.**

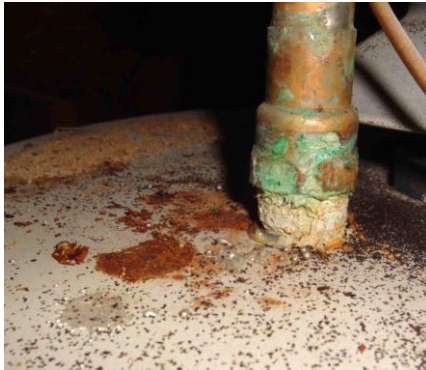
**-The water heater supply lines were corroded.**

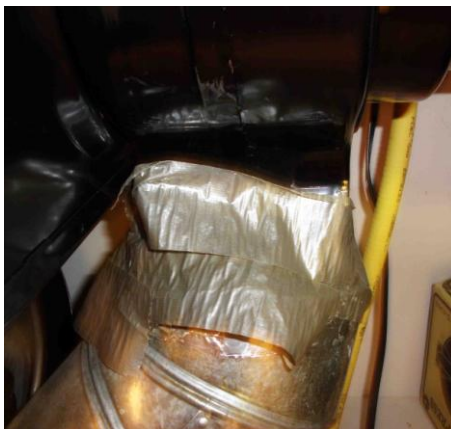
**-The downdraft exhaust vent is improperly connected together with 'tape'.**

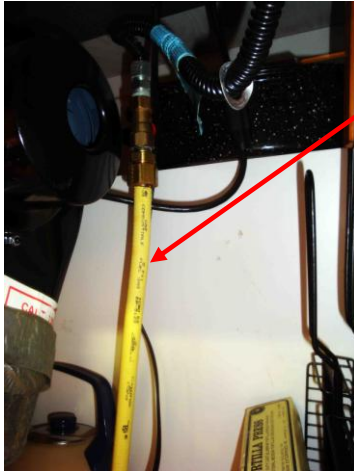
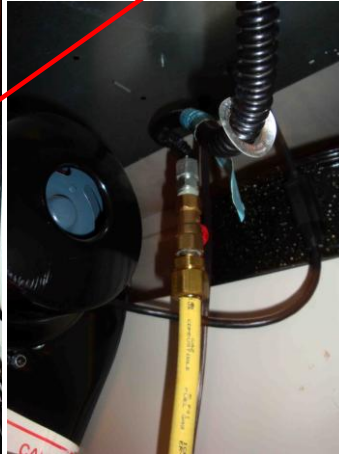
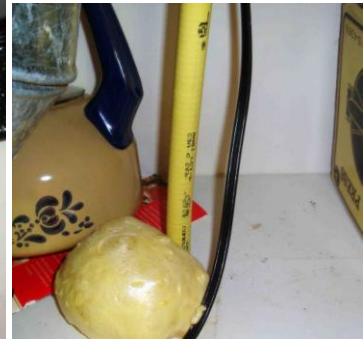
-The gas line supply to the kitchen island cooktop is 'flexible plastic' which is **NOT allowed by code**. (Plastic gas lines can ONLY be used 'outside' and 'underground'. Plastic gas line 'cannot' be used 'inside' the house, or 'under' the foundation)

(NOTE: See the 'yellow' plastic gas line in the following photos)

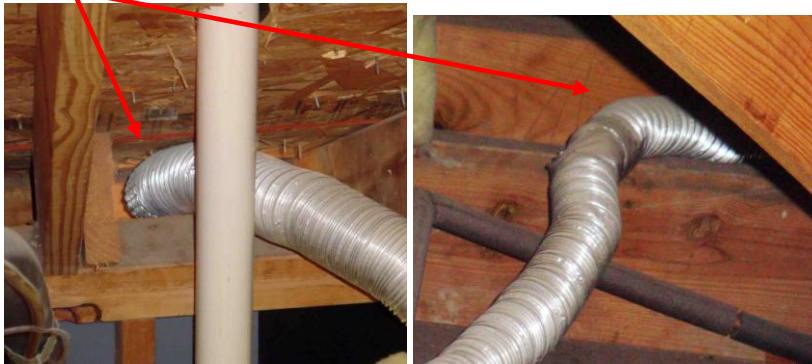
**-Mechanical exhaust vent(s) do not exit to the outside air as required. (terminating into a 'soffit' is not allowed)**
