PROPERTY INSPECTION REPORT

Concerning: **1234 Anywhere Lane The Woodlands, Texas 77380**

By: **Rodney Sims / Lic# 10271**

2/10/2010 / 9:00am

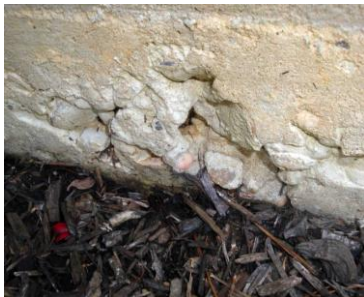
-A post tension cable end was visible in the front. (These cable ends should be coated with appropriate sealant to protect the cable from moisture)

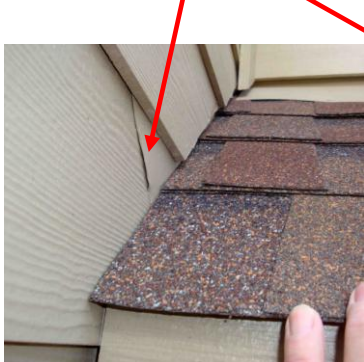
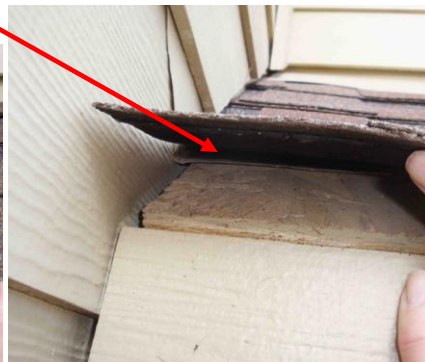
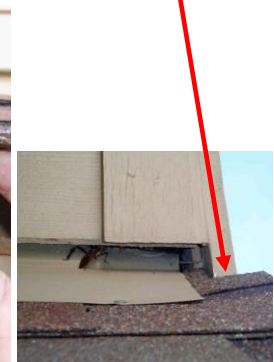
-On the lower part of the chimney, where the small roof rake meets the vertical siding, the J-Flashing terminates several inches above the lower edge of the shingles.

-On the outer edge, the 'Apron flashing' should continue all the way to the outermost edge of the chimney siding.

-The same situation exists on the other side of the chimney also.

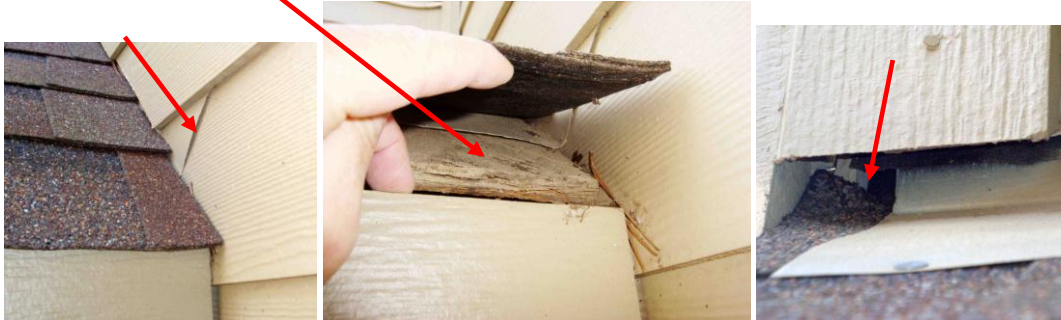
NOTE: Moisture meter testing on the decking under the shingles in the area indicated a current high 35% moisture content.

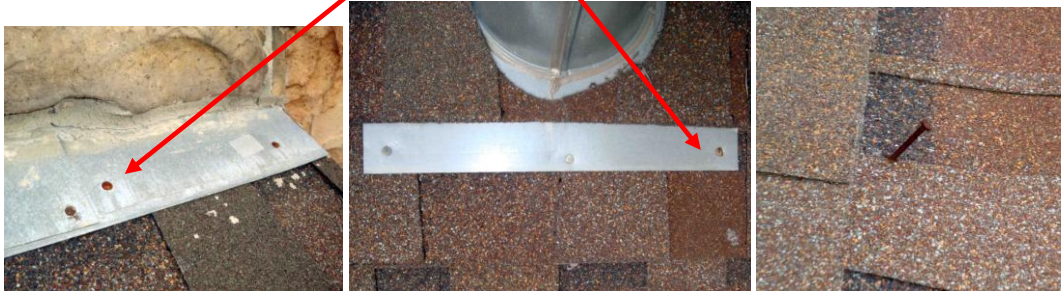
-In 'several areas', there were exposed nail heads on the on the apron flashing. (these should be sealed to prevent leakage)

-Exposed nail heads were noted on several roof jack flashings

-On the left side small roof rake, a nail is protruding into the shingles.

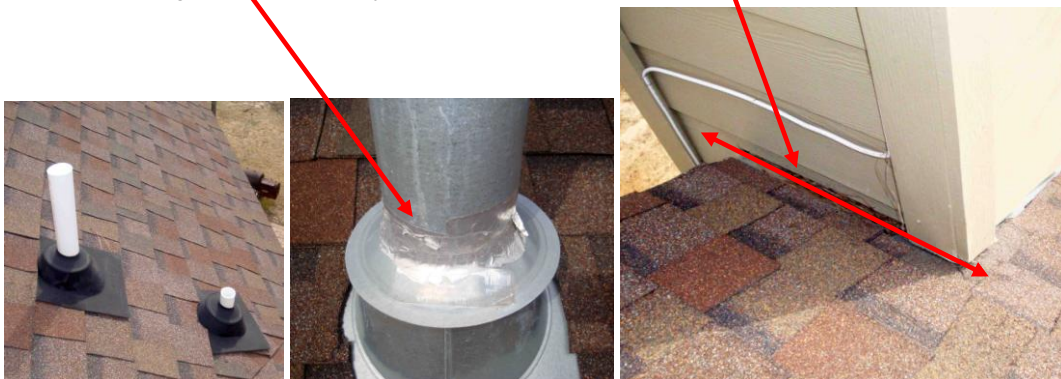
-PVC vents should be painted as required. (This prevents deterioration by the sun's UV rays)

-One roof jack has tape sealing the rain collar to the vent pipe.

-The metal flashing on the upper side of the chimney is not installed correctly. There should be a horizontal 'Head Flashing' in place which acts as a water shed to transfer rain water to either side of the chimney structure extending 'several inches' on each side. (Please see photos below, as well as the diagram. The diagram provided is actually for a 'brick' chimney, but the head flashing 'technique' is very similar)

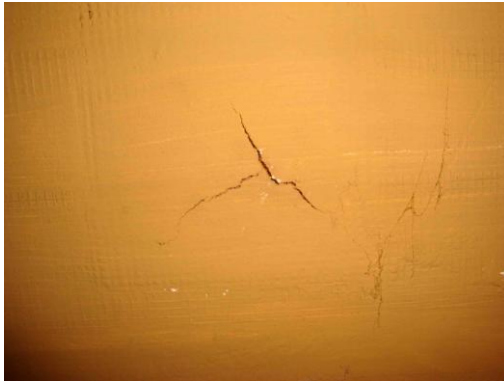
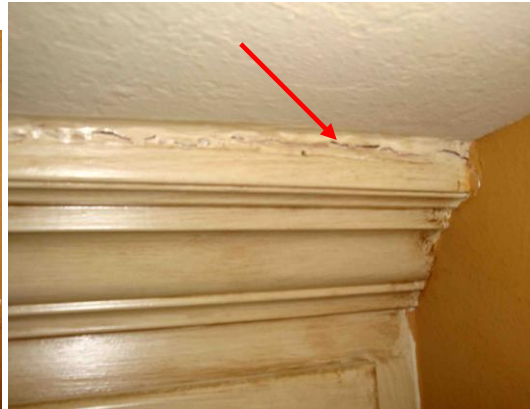
-In the Kitchen, on top of the cabinets on the outer wall, there is evidence of a prior drywall patch.

-In the Kitchen, on top right of the cabinets on the outer wall, it appears that the cabinets have been re-sealed to the ceiling.

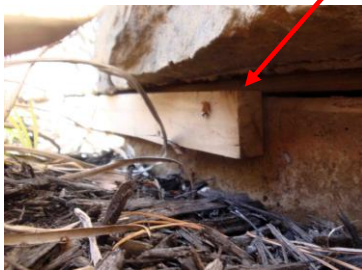
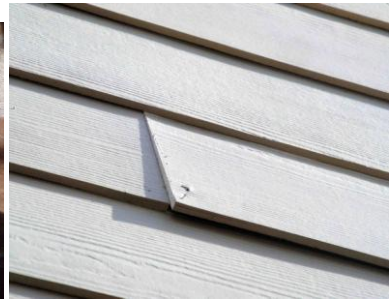
- On the right side, a (temporary) 1x2 board under the stone should be removed.
- On the right side, the wall penetration for the low voltage lighting should be sealed better.
- On the right upper side, a hardy board should be secured better and resealed on the end.

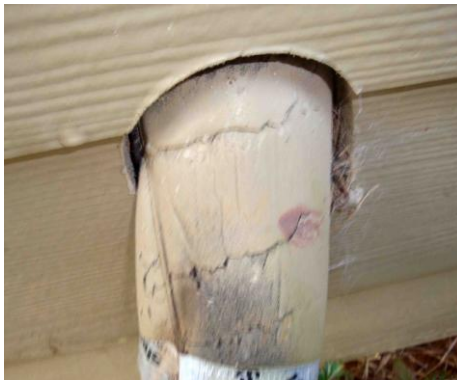
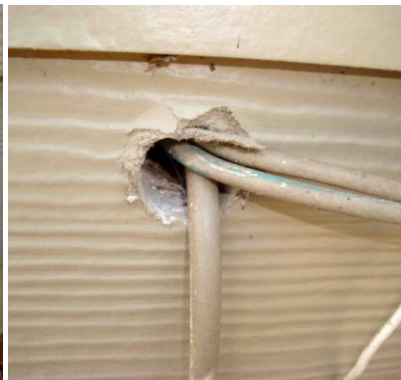
- The A/C refrigerant line should be sealed better where it penetrates the wall.
- A hole in the wall for wiring should be sealed.

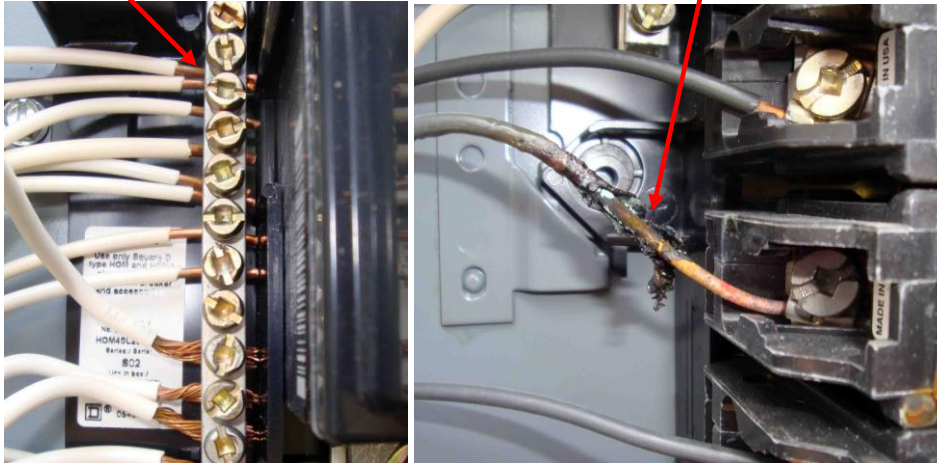
- Most of the breakers are not labeled as required.
- The white wires used as hot wires are not marked as such.
- The A/C outside condenser unit specific a Max Fuse (breaker) size of 40-Amps. However, the breaker in the panel for the A/C condenser is a 60-Amp breaker. (This mismatch is recommended max size should be corrected. It is considered a fire hazard)
- 'Some' of the required locations in the house were protected by Arc Fault Breakers as is required by current building code. Even though this may have not been required at the time of construction, TREC requires that licensed inspectors flag this condition with a "D" for "Deficiency". For more information, refer to the TREC OP-I Form at the end of this report.

- ‘Double lugging’ of wires was noted on several lugs on the neutral bus bar.
- One of the branch circuit conductor wires is significantly burned.

☒ Due to issues observed, recommend service and system check by licensed electrician.

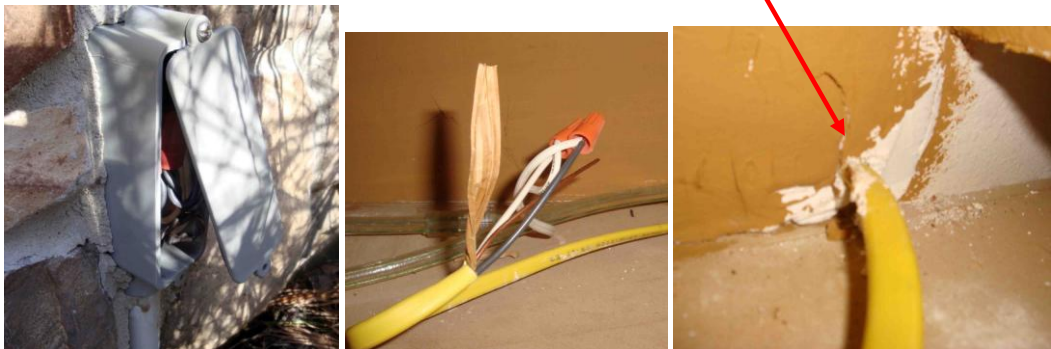
- In the kitchen, the 2 receptacles on the wall to the right of the range, are not GFCI protected.
- None of the receptacles in the garage were GFCI protected as required.
- None of the receptacles at the back deck kitchenette were GFCI protected as required.
- The two upstairs bathroom GFCI receptacles are incorrectly wired together 'in series'.
- The receptacle on the garage ceiling has no face plate.
- On the right center, an external junction box cover should be secured.
- In the Kitchen, on top of the cabinets on the outer wall, there is an unprotected wire splice.
- In the Kitchen, on top of the cabinets on the outer wall, an unprotected romex wire passes directly through the drywall.

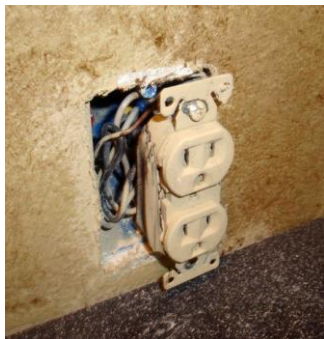
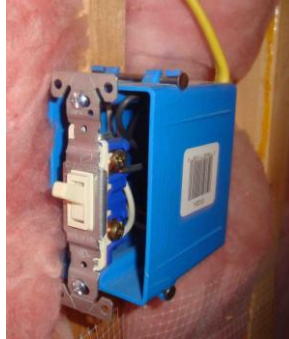
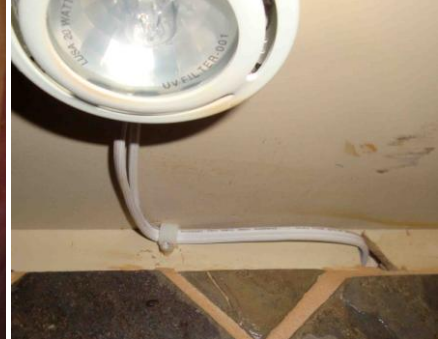
- In the study, on the countertop in the alcove, the receptacle yoke is hanging out of the wall, and does not have a face plate.
- In the attic, one light switch box has no face plate.
- Extension cord wire used as 'permanent wiring' for lights under kitchen cabinets.

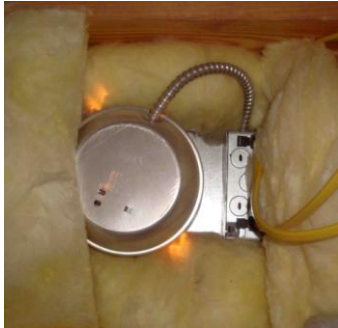
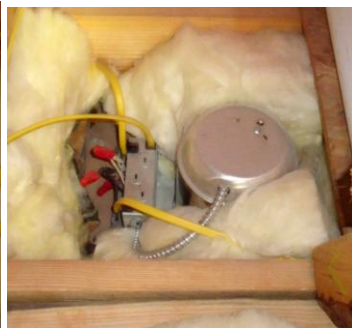
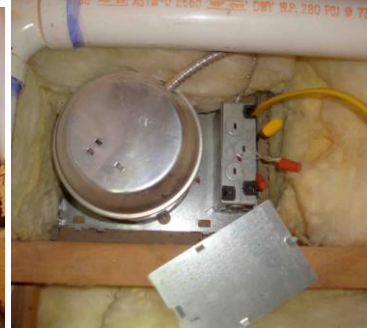
-Several of the recessed light cans in the attic were **NOT RATED** for direct contact with combustible materials. (This is a fire safety requirement) (There was direct contact with the insulation)

-Several of the recessed light cans also had 'open wire splices' at the built-in junction box on the light.

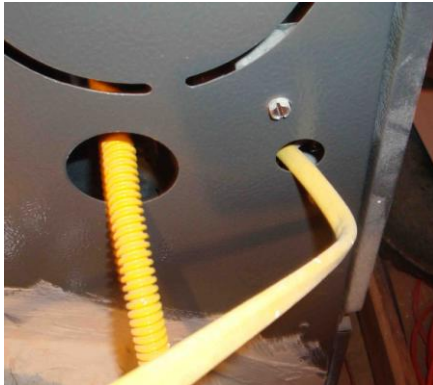
-The gas line to the furnace did not have the required 'drip leg' (sediment trap). (This prevents any sediment from entering the furnace burners)

-The furnace power cord for the blower motor does not have the required 'grommet protection' where it enters the furnace.

-The flexible gas line is not allowed to pass through the wall of the furnace. (It must be concerted to 'hard pipe' before passing through the furnace wall) (See the diagram below for an example of a gas pipe 'drip leg' AND how 'hard pipe' should pass through the wall of the furnace.

- ☒ Due to issues observed, recommend service by qualified H.V.A.C Service Company
Note: Gas furnace heat exchangers cannot be thoroughly inspected without disassembly.

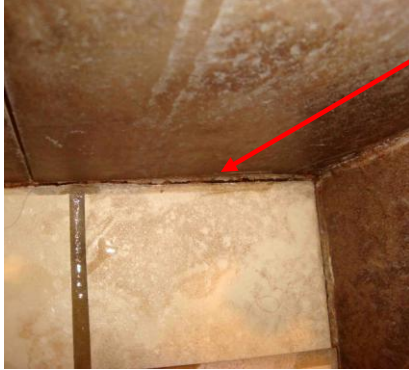
-The master bath shower has a few small spots where the grout is cracked or missing.

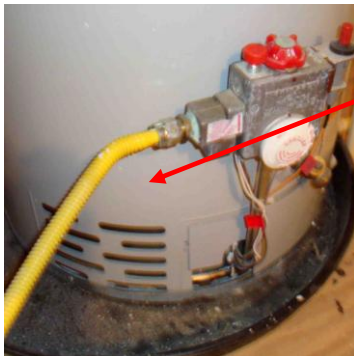
-The gas line to the water heater did not have the required 'drip leg' (sediment trap). (This prevents any sediment from entering the water heater burners)

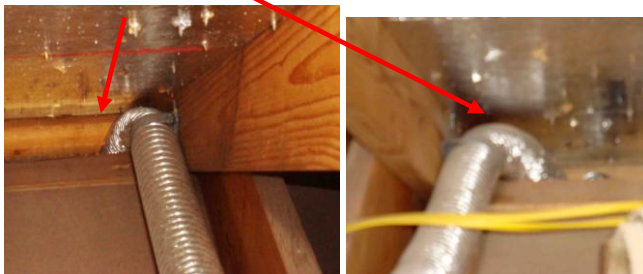
-At least two mechanical exhaust vent(s) do not exit to the outside air as required. (exiting into a soffit is 'not' allowed)
