PROPERTY INSPECTION REPORT

Concerning: **1234 Anywhere Lane The Woodlands, Texas 77380**

By: **Rodney Sims / Lic# 10271**

2/10/2010 / 9:00am

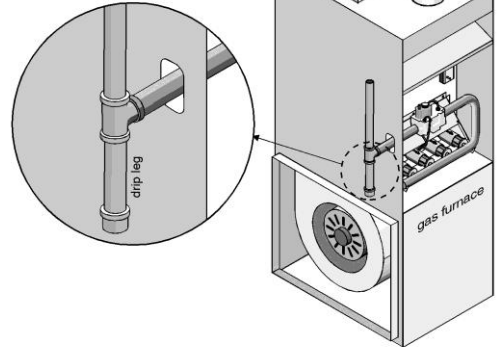
**Drip leg**

-The gas line to the furnace did not have the required 'drip leg' (sediment trap). (This prevents any sediment from entering the furnace burners)

the drip leg (or dirt pocket) serves as a collection area for sediment to reduce the chance of clogged gas valves or burners

- ☒ Due to issues observed, recommend service by qualified H.V.A.C Service Company
Note: Gas furnace heat exchangers cannot be thoroughly inspected without disassembly.
